Case report

Use of ultrasound Doppler to determine tooth vitality in a discolored tooth after traumatic injury: its prospects and limitations

Yong-Wook Cho, Sung-Ho Park*

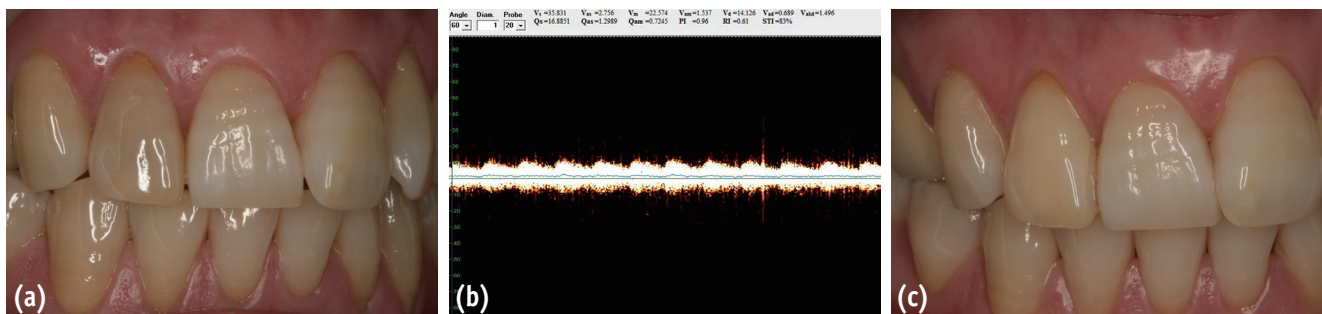
Figure 1. (a) In case 1, discoloration of tooth #12 was observed at 2 weeks after the injury; (b) The result of an ultrasound Doppler test at 6 weeks after the injury. It shows a typical pulsated image, which represents normal vital pulp; (c) At 10 weeks after the injury, the tooth had returned to a normal shade.

A 47-year-old female patient visited our department due to traumatic injury to her upper right lateral incisor (tooth #12). She sustained the injury 3 days before she visited our clinic by a fist blow injury to her face. Tooth #12 was subluxated, and showed a positive response to a percussion test. It did not show any response to a cold test or EPT. The tooth was diagnosed with subluxation, and we decided to wait and observe its course. There was no discomfort during the 2 weeks after the injury, but there was no response to the thermal test or EPT, and a reddish discoloration was observed (Figure 1a).

At 6 weeks after the injury, the patient did not show any discomfort, but the discoloration lasted, and the tooth did not respond to cold or EPT. We decided to use the ultrasound Doppler unit to evaluate the vitality of the pulp, and the result was shown in Figure 1b. Tooth #12 produced a typical pulsated image, which represents normal vital pulp (Figure 1b). We explained the results and implications of the test to the patient. We decided to continue to wait and observe the tooth because the patient had no discomfort, did not mind the discoloration at that time, and was willing to wait to determine whether the tooth could recover to normal without any treatment. At 10 weeks after the injury, the tooth had returned to a normal shade and regained its normal responses to the cold test and EPT (Figure 1c).

In the first case, the ultrasound Doppler showed a typical pulsated image when the tooth did not respond to the cold test and EPT in the early phase after a traumatic injury. Then, in ongoing follow-up, the Doppler test continued to show vital image, but the tooth still did not respond to the other two tests. The tooth regained its shade by 10 weeks after the traumatic injury, and its response to the cold test and EPT returned to normal. This finding is consistent with previous reports that indicated that the discoloration returned to normal when the teeth regained their vitality and demonstrating that ultrasound Doppler can be successfully used to determine the vitality of teeth during the period when they do not respond to the cold test and EPT after a traumatic injury.⁴⁻⁸ Ultrasound Doppler may help decrease unnecessary endodontic treatments, which could be performed due to a lack of the proper diagnostic methods after a traumatic injury.

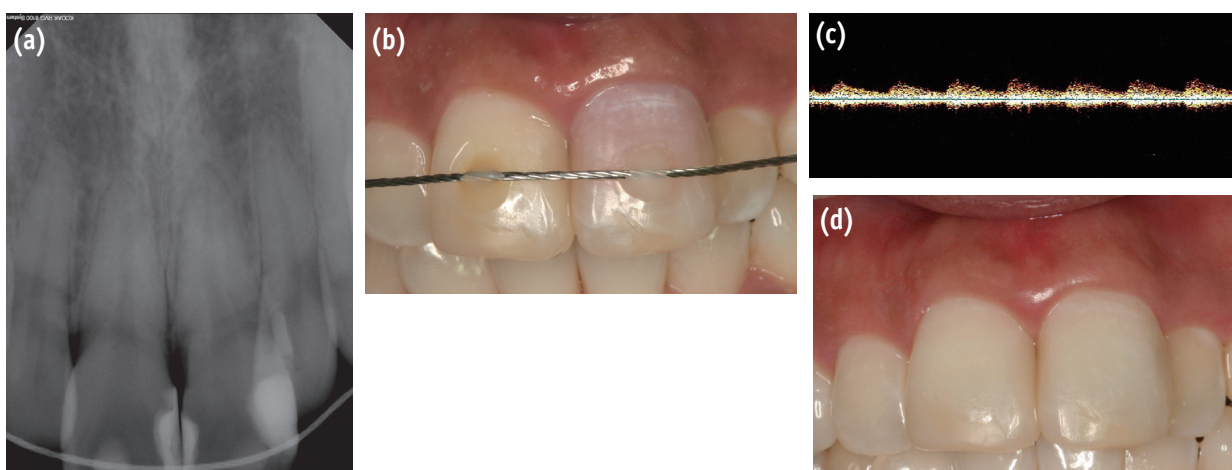
Figure 2. (a) In case 2, tooth #21 was splinted at a local clinic after a subluxation injury that had occurred 2 weeks before the patient visited our clinic. It showed a negative response to the thermal test and EPT, and a positive response to the percussion test; (b) Tooth #21 showed pinkish discoloration; (c) In the ultrasound Doppler test, tooth #21 showed a normal pulsated response like that of the other teeth; (d) At 10 weeks after the injury, the shade of tooth #21 had returned to normal.

A 30-year-old female patient visited our clinic for further treatment of traumatized anterior teeth. She had sustained an injury from a fall 2 weeks ago, and had visited a local clinic immediately after the trauma. The subluxated tooth #21 was splinted with composite resin and wire from tooth #13 to tooth #23, and then the local dentist referred her to our clinic. In the periapical radiographic view, the root and periapical area were normal (Figure 2a). Tooth #21 showed negative responses to the thermal test and EPT, a positive response to the percussion test, and pinkish discoloration (Figure 2b). The other teeth showed normal responses to all of the tests. In the ultrasound Doppler test, tooth #21 produced a normal pulsated response like those of the other teeth, and we were also able to hear the beat of the pulsation from the speaker (Figure 2c). At 4 weeks after the injury, tooth #21 showed normal response to percussion, again. In the other tests, the results were also the same as in the previous visit. At 6 weeks after the injury, tooth #21 still showed pinkish discoloration and negative responses to the thermal test and EPT. At 10 weeks after the injury, the shade of tooth #21 returned to normal (Figure 2d). At 12, 16, 20, and 24 weeks after the injury, the patient did not feel any discomfort at all. In the ultrasound Doppler test, tooth #21 showed a vital response, but it did not respond to the cold test or EPT. In the periapical view, the root and periapical area were within the normal range. The negative response continued throughout the follow-up period for 9 months. At that time, she was pregnant and wanted to delay her next visit until after her delivery.

months after root fracture resulting in tooth discoloration after trauma.⁶ The second case was interesting in that the discoloration returned to normal by 10 weeks after injury, but the tooth did not respond to the cold test and EPT even at 9 months after the traumatic injury, although it showed a consistent vital image in the Doppler test from the beginning. False positive responses in the ultrasound Doppler test have not yet been studied. In the present study, a 20-MHz ultrasound Doppler probe was used. The frequency of ultrasound is very important because it determines the penetration depth of the ultrasound wave. Although a 20-MHz frequency was reported to efficiently penetrate the enamel and dentin, and detect the blood flow in the pulp spaces, it might be possible to detect the blood flow outside of the pulp spaces if the thickness of the hard tissue is very thin.^{1,12} The potential for false positive responses with the ultrasound Doppler probe requires further investigation. In the second case, long-term follow-up is necessary to verify whether the vitality was actually maintained, which could be confirmed by a positive response to the cold test and EPT. However, in this case, the tooth returned to its normal shade by 10 weeks after the traumatic injury, which suggests that the blood supply to the pulp was maintained and the pulp survived.⁶ More time might be needed for the nerve fiber to heal. Further follow-up is required to determine whether the test results are true or false positive.

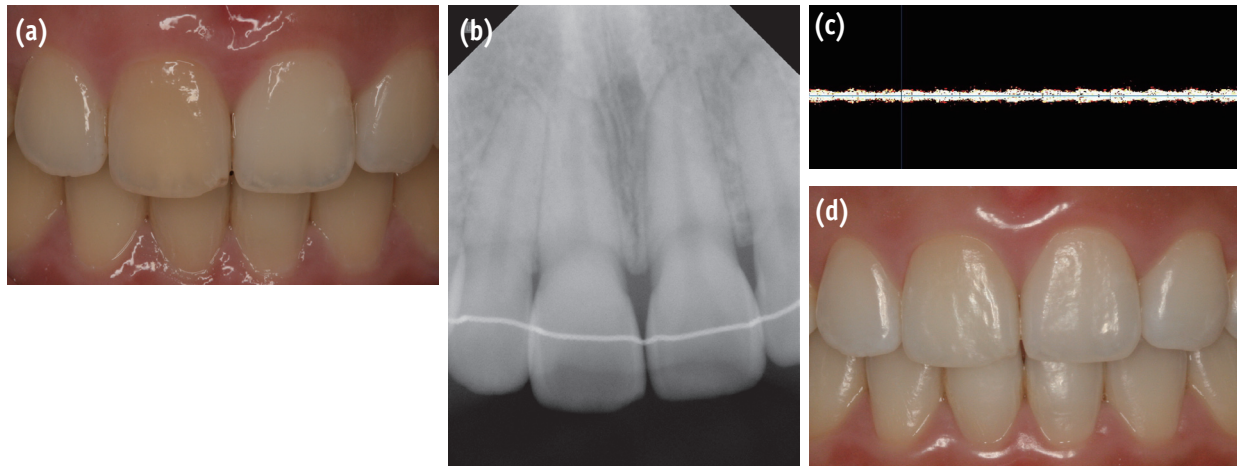
Figure 3. (a) In case 3, tooth #11 showed yellowish brown discoloration; (b) The coronal pulp space was obliterated, whereas the pulp space was present in the root area. There was no radiolucency in the periapical area, but the root apex was slightly shortened; (c) In the ultrasound Doppler test, tooth #11 showed an image typical of a vital tooth; (d) The patient was satisfied with the shade of tooth #11 after vital bleaching treatment.

A 22-year-old female patient visited our department to have her teeth bleached. She thought her teeth were generally yellowish, and she was especially unsatisfied with the shade of tooth #11, which showed yellowish brown discoloration (Figure 3a). She reported experiencing trauma to her anterior teeth when she was in primary school, and she had finished orthodontic treatment approximately 7 years before presentation. However, she did not know exactly when tooth #11 started to become discolored. In the radiograph, the coronal pulp space was obliterated, whereas the pulp space was present in the root area. There was no radiolucency in the periapical region, but the root apex was slightly shortened (Figure 3b). In the cold test, tooth #11 did not show any response, although she occasionally displayed a delayed response. The tooth did not respond to the EPT. In the ultrasound Doppler test, tooth #11 showed an image and sound typical of a vital tooth (Figure 3c). We decided to perform vital tooth bleaching first and then re-evaluate the color to decide whether restorative treatment was needed. Home bleaching was started using 15% carbamide peroxide gel (Opalescence, Ultradent, South Jordan, UT, USA). Additional home bleaching was continued only for tooth #11 after she was satisfied with the shade of her other teeth. After approximately 2 months of bleaching, she was satisfied with the shade of tooth #11 and did not want any further treatment (Figure 3d).

In the third case, the patient did not respond to the cold test and EPT, although she occasionally showed an obscure positive delayed response to the cold test. The cold test depends on the hydrodynamic movement of fluid within

the dentinal tubules, which excites the A-fibers.¹³ Teeth with calcified pulp spaces might have normal and healthy pulps, but cold stimuli might not be able to excite the nerve endings due to the insulating effect of the thicker layer of dentin, which is the result of secondary and reactionary dentin formation.¹⁴ Ehrmann reported that EPT is particularly effective in older patients and in teeth that have limited fluid movement through the dentinal tubules as a result of dentine sclerosis and calcification of the pulp space because thermal pulp tests are usually inadequate in these situations.¹⁴ Klein reported that a patient was unlikely to respond to a cold test but may respond to an EPT if the pulp space had been significantly calcified.¹⁵ In their case, more electric pulp current was often needed to elicit a response because there was an increased dentin layer and a diminished pulp cavity or a fibrotic pulp. In the third case, tooth #11 was diagnosed as a vital tooth based on the results of the ultrasound Doppler test because it displayed a consistent positive sign throughout the observation period. In this case, the coronal pulp space was obliterated, whereas the pulp space was present in the root area. Because the ultrasound Doppler probe tip was positioned apically, there was a possibility of detecting the blood flow of the root canal. Furthermore, the patient showed a response to the cold test, although the response was delayed and inconsistent. For further research, we need more cases and studies related to ultrasound Doppler.
